RIVERBANK EROSION IN PART OF TIBO VILLAGE, DONGGALA REGENCY

Rendra Zainal Maliki^{1,*}

¹Geography Education, Universitas Tadulako

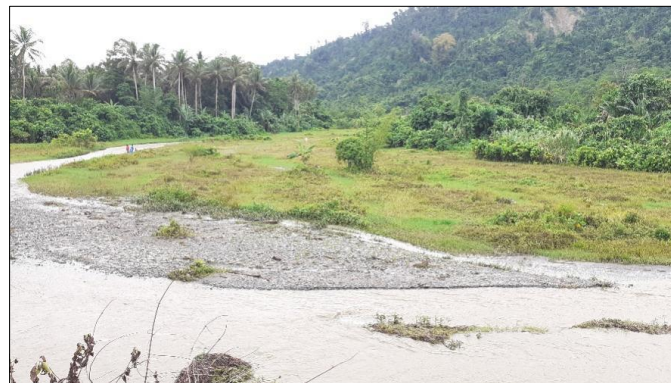
Figure 2. Point Bar Caused Transport Sediment

transported material is mostly deposited on the middle side of the river which forms the river channel (Figure 2) and is deposited in the lower part of the river bordering the sea. Geomorphological processes such as erosion caused riverbanks to continuously decline, resulting in cliff landslides. Riverbank landslides are the impact of river flows that have high destructive power and can

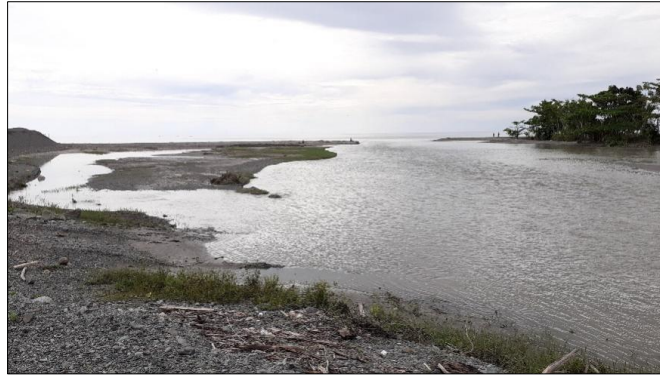
Figure 3. Downstream of Tibo Village River

high runoff so that some land on the banks of the Tibo river is also eroded by the flow of water. The high flow rate of the river is the main factor in eroding the river bank. The amount of sediment deposited along the river causes the downstream to experience siltation (Figure 3). Transport of sediment in the downstream or estuary also causes marine pollution.

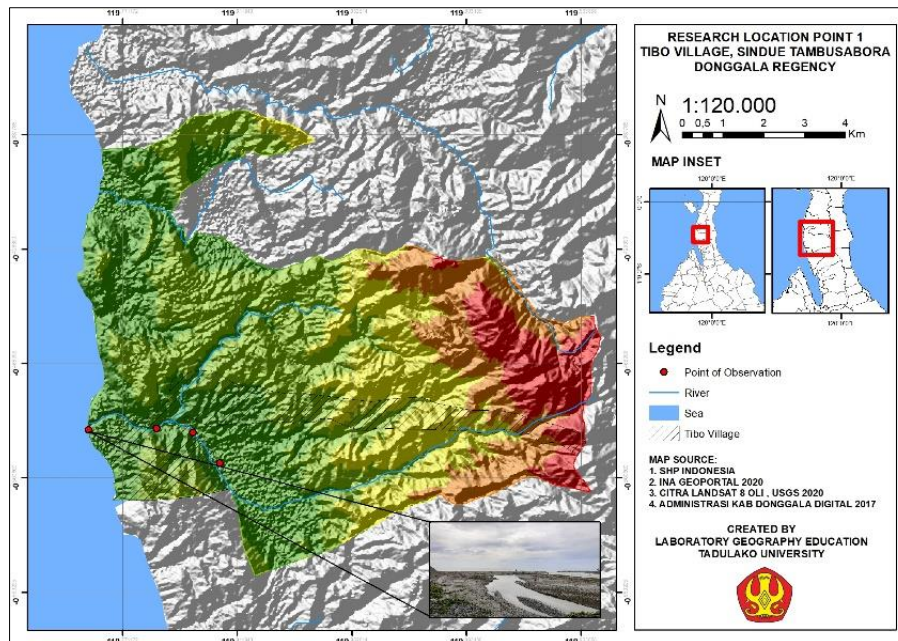
Figure 4. Observation Map of Point 1, Downstream of Tibo Village River

There are 4 observation points in the field which are river water scouring and sedimentation. At the first point, namely observations at the mouth of the river. At this point, the sedimentation due to the high flow of the river causes silting in downstream. A lot of sediment transport in the form of river material is also carried to this point. The silting of the river is also not more than 1 meter, meaning that if at any time there is heavy rain with high intensity and long duration, the area around the river will experience impacts such as overflowing river flows due to high sedimentation.

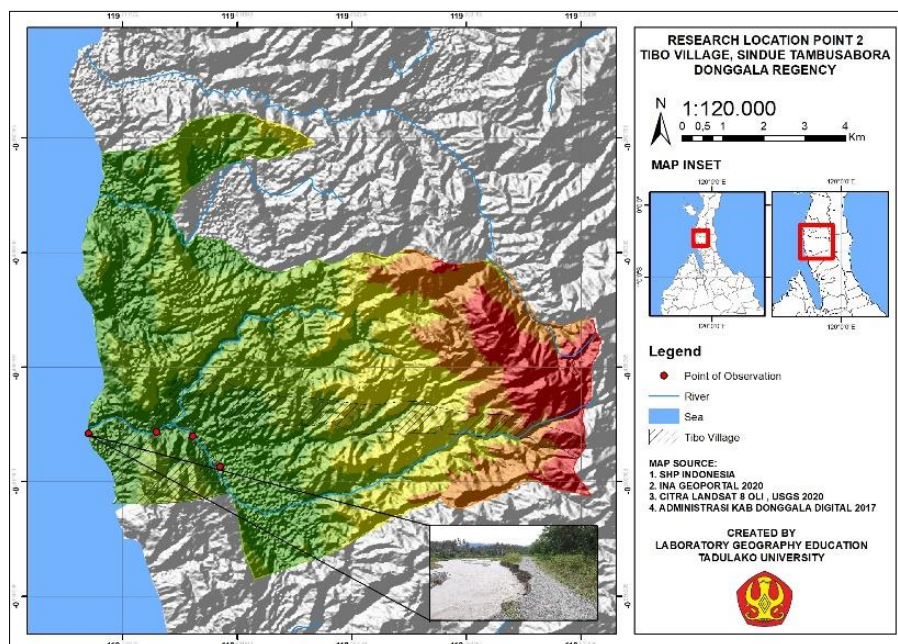
At point 2 of the observation location in the field, there is a river scour on the side of the road. This road is the shortest route to get to the residents' plantations. The strong river discharge at the research site caused the road conditions to be almost cut off. The

avalanche length reaches 8 meters with a landslide height of 1 meter. There needs to be a barrier on the side of the road because the position of the road is right next to the river and is a river bend so that the speed and damage are high.

Figure 5. Observation map of point 2, scouring the river on the side of the road

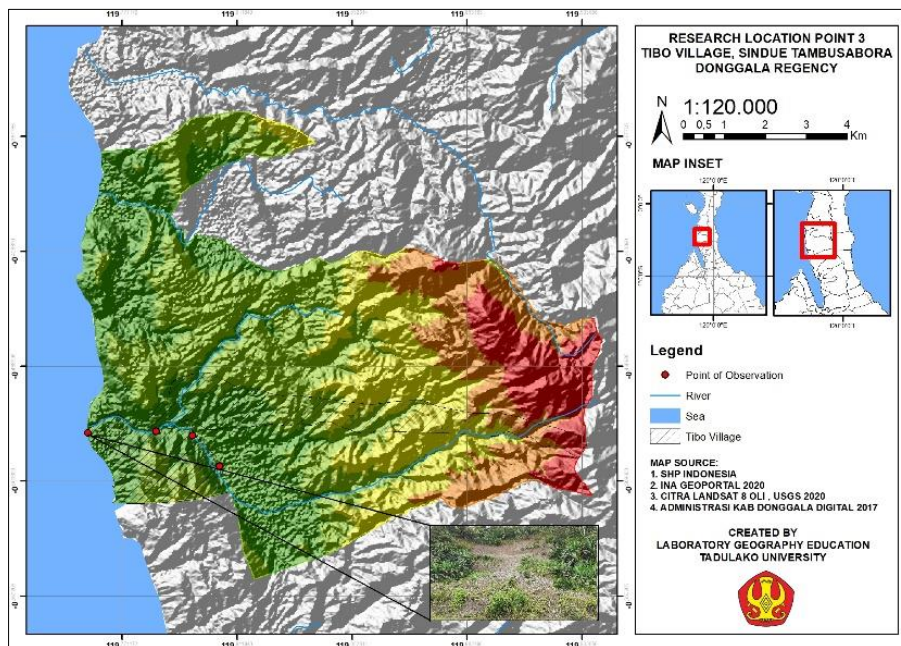
Figure 6. Observation Map of Point 3

At point 3 the observation location in the field there is an avalanche on the side of the road leading to the next village, namely the village of Saloya. The road is the main access to go to other villages that are close to each other. The height of the avalanche reached approximately 20 meters which were right on the side of the road. The landslide occurred due to high rainfall and the conversion of forest land into plantations so that there were no strong plant roots to withstand the heavy

rain. The vegetation which is dominated by shrubs accelerates the occurrence of landslides. In addition, the condition of steep slopes, less dense soil, and rocks that are not strong are the driving factors for landslides. The change of soil to mud due to vegetation in the form of shrubs causes high runoff and triggers landslides. In steep areas, it is best to plant trees with strong roots so that they will reduce the occurrence of landslides.

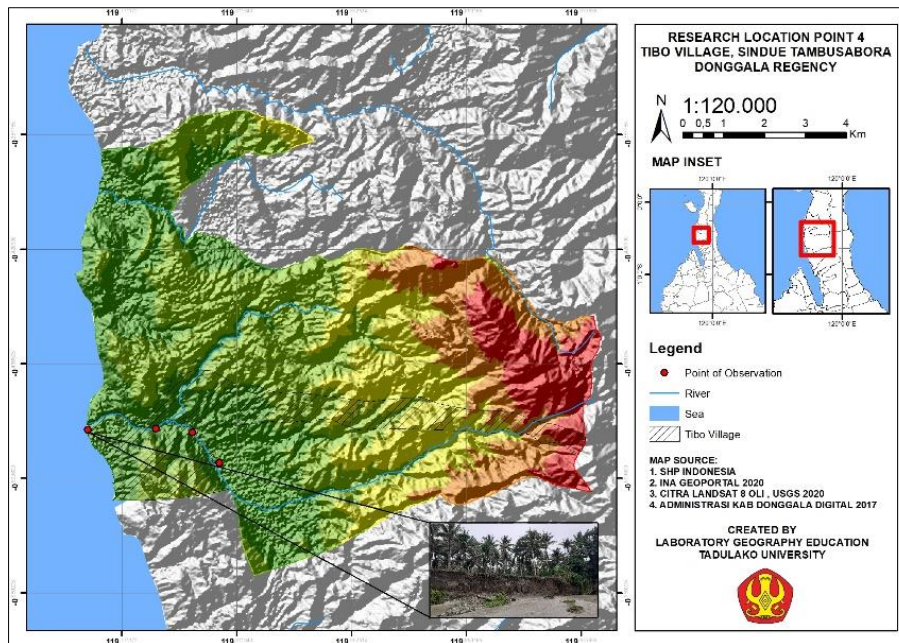
Figure 7. Observation Map of Point 4, Cliff Erosion Beside People Gardens

At point 4 of the observation location in the field, there is the erosion of the cliffs next to the people gardens. The high river discharge causes cliff erosion which erodes the plantations of the Tibo village community. Plantations located right at the bend of the river have

a high impact on cliff erosion. If this is left without any mitigation to prevent cliff erosion, the community's plantations will be completely eroded. The strength of scouring on riverbanks can make changes in river flow that will widen the width of the river.

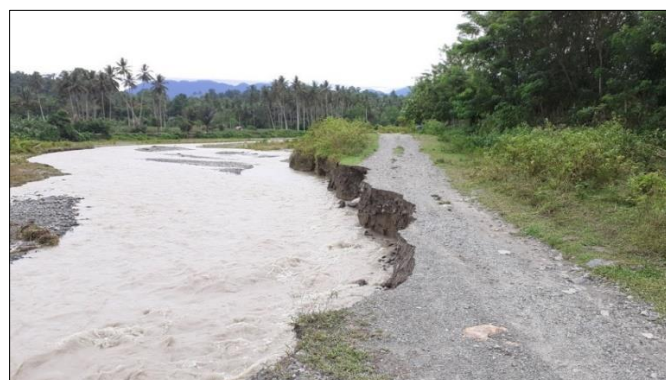
Figure 8. Slide of The Side Road

One of the rivers in Tibo village damaged the alternative road to the next village. This cliff avalanche has a length of approximately 8 meters and a width of

about 3 meters. The absence of embankments blocking the river flow resulted in the erosion of the road. The high river discharge is the main factor in

the cliff landslide in Tibo village. If this is not done with mitigation efforts to overcome landslides when it rains for a long duration with high intensity, the road will be completely cut off which will have an impact on the activities of the village community.

Efforts need to be made to overcome these problems by making embankments to prevent river flow with gabions, namely the results of woven wire or bamboo filled with stones so that scouring of river flows can be minimized. In addition, riverbank erosion can be reduced by planting vegetation along the riverbank. These efforts can be carried out at points that are prone to cliff landslides, namely around river bends. Vegetation or plants can provide a roughness of the cliff to the flow of water,

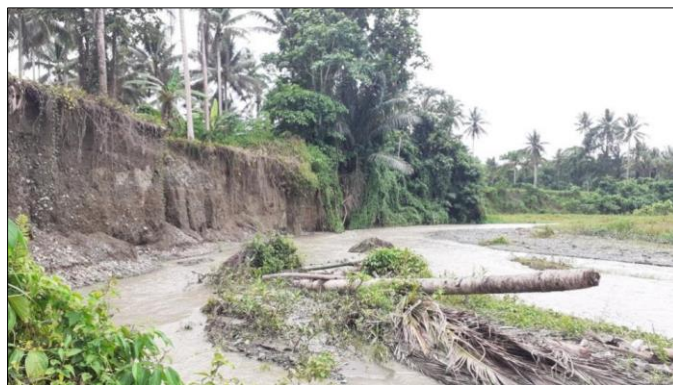
Figure 9. Erosion at The Bend of The River at Tibo Village

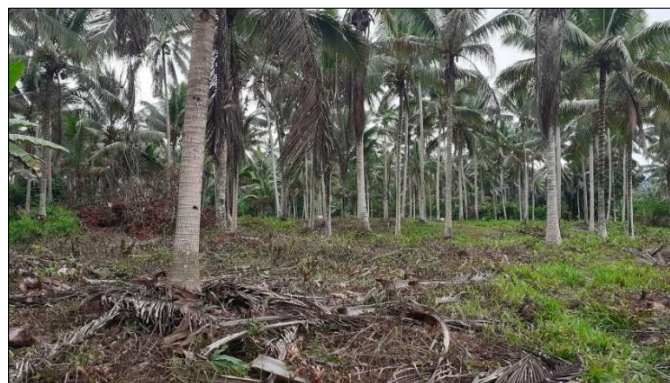
Land use in the research area is in the form of agricultural land, including coconut, corn, banana, and other fruit crops. The land use beside the Tibo river

is coconut trees. The location of the plantations that are on the river border is very at risk of cliff erosion. The river flows under community plantations can erode plantation land in the event of high-intensity rain. Quality land has a high level of plant productivity. The amount of productivity of a plant is influenced by several factors, including resistance to erosion (related to relief), water availability, and soil fertility (Imam Hardjono, 2016). The upstream part of this river is a mountainous area, while the middle part is used for plantations, besides that there are also people's houses. In the middle part is the transitional part, there are rice fields, gardens for farming, and a few settlements. The downstream part of the river is dominated by residential areas. To determine the occurrence of erosion at a dangerous level or a threat of land degradation or not, it can be seen from the level of erosion hazard of the land (Ardiansyah et al., 2013).

Figure 10. Land Use in Tibo Village
