# Analysis of Pedestrian Accessibility for People with Disabilities on Adinegoro–Perintis Kemerdekaan Corridor, Medan City

<sup>1</sup>Architecture Study Program, Faculty of Engineering, Universitas Negeri Medan, Medan, Indonesia

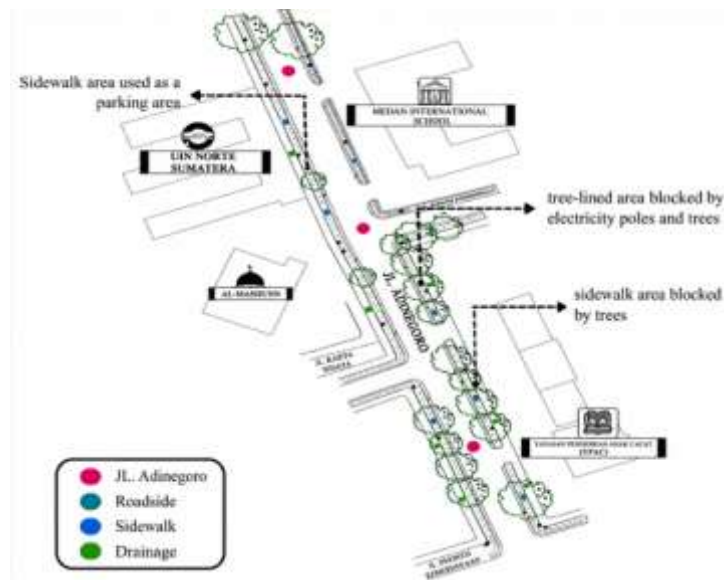
**Figure 3. Spatial Distribution of Sidewalk Damage and Physical Barriers along the Adinegoro–Perintis Kemerdekaan Road Corridor**

The physical barriers observed in the field were also quite diverse and scattered along the corridor. Permanent barriers included 27 shade trees planted in the middle of the sidewalk, 18 utility poles and telephone poles standing directly in the pedestrian path, and open drainage channels in Segment B that lacked covers or safety guards. Meanwhile, temporary obstacles include 12 illegal parking spots with an average of 2–3 vehicles at each spot using the sidewalk as a parking area, 8–10 street vendors selling on the sidewalk, particularly in Segment A, as well as piles of trash and construction materials at several locations. The coordinates of each obstacle have been recorded and displayed on the spatial distribution map in Figure 3.

The impact of these obstacles is significant. At certain points, the effective width of the sidewalk can narrow to just 30–50 cm, which is not even enough for a single adult to pass comfortably. As a result, pedestrians are forced to step onto the road—which is crowded with vehicles—to avoid these obstacles. This situation is corroborated by interviews with informants. A security guard in the area stated, “Rarely does anyone use the sidewalk; people have even fallen there.” A motorcycle taxi driver also confirmed, “The sidewalk is damaged; most people walk on the road.” Families of YPAC users even called this route dangerous and stated that guide paths and safety barriers are needed.

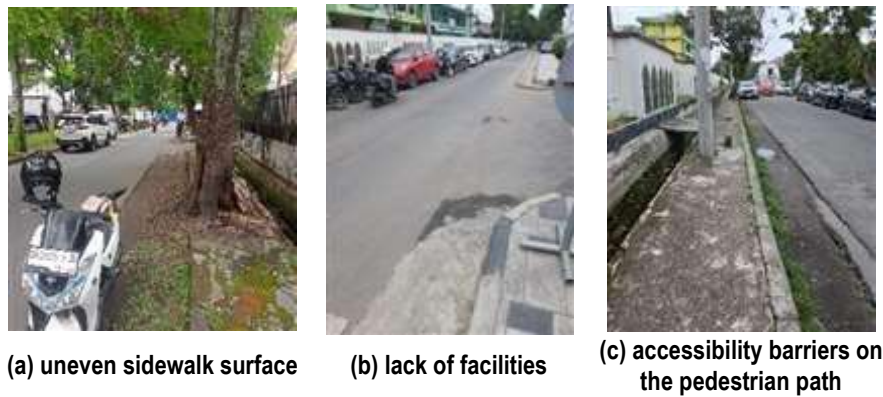
**Figure 4. Existing Condition of the Pedestrian Path**

Field observations indicate that the physical condition of sidewalks along the corridor generally falls into the poor to very poor category. The width of the sidewalks, measured at 20 different points, varies between 95 cm and 125 cm, with an average of 110 cm. This figure is far below the minimum standard set by the Ministry of Public Works and Public Housing Guidelines Number 07 of 2024, which requires 150 cm for two-way pedestrian paths, and also falls short of the standard in Ministry of Public Works and Public Housing Regulation Number 14 of 2017, which mandates a minimum width of 120 cm for accessible pathways. This inadequate width prevents two pedestrians from comfortably passing each other, and wheelchair users have absolutely no sufficient space to maneuver, let alone turn or pass other users.

The sidewalk surface also showed significant material degradation. At nearly all observation points, cracks, potholes, poorly applied patches, and the growth of moss and grass were found, as illustrated in Figure 4. These conditions caused the surface to become uneven and slippery, posing a high risk of pedestrians slipping or tripping. These findings align with Cohen et al. (2020) who explain that hazards on sidewalk surfaces, such as cracks, potholes, and unevenness, can increase the risk of falls among pedestrians in urban areas.

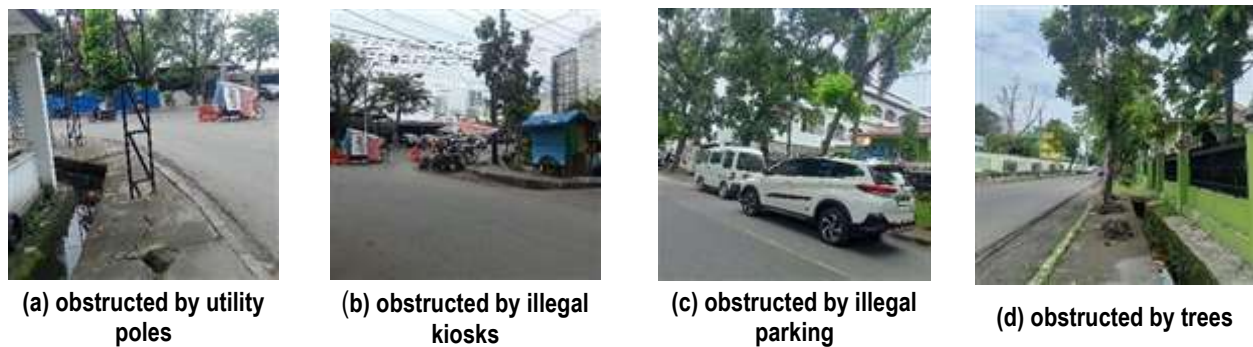
**Figure 5. Obstacles on the Pedestrian Path**

The physical barriers identified in the field are highly varied and scattered along the corridor. Permanent barriers include 27 shade trees planted in the middle of the sidewalk, 18 utility poles and telephone poles standing directly in the pedestrian path, and open drainage channels along Segment B that lack covers or safety barriers. Temporary obstacles include 12 illegal parking spots with an average of 2–3 vehicles per spot using the sidewalk as a parking area, 8–10 street vendors selling on the sidewalk, primarily in Segment A, as well as piles of trash and construction materials at several locations. Examples of these physical barriers are shown in Figure 5. The coordinates of each identified obstacle were recorded and displayed on a spatial distribution map in Figure 3.

The impact of these obstacles is significant. At points with obstacles, the effective width of the sidewalk can be reduced to as little as 30–50 cm, which is not even sufficient for a single adult pedestrian to pass through. Consequently, pedestrians are forced to step onto the road, which is crowded with vehicles, to avoid these obstacles. This situation is corroborated by interview results with informants. A security guard in the area stated, “Rarely does anyone use the sidewalk; people have even fallen there.” An ojek driver also confirmed, “The sidewalk is in ruins; people mostly walk on the road.” Families of YPAC users even described the path as dangerous, saying, “It’s dangerous to walk on the sidewalk; there should be guiding blocks and a fence.”

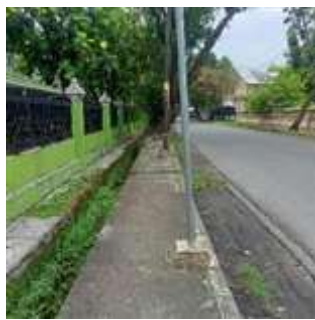
Accessibility facilities that should support the mobility of disability communities are virtually nonexistent in this corridor. Tactile paving (guide paths) is found only at a very limited number of points (less than 5% of the total length of the corridor), and even then, it is discontinuous due to obstacles such as trees, utility poles, or parked vehicles. The color of the available guiding blocks also lacks contrast with the surrounding sidewalk surface, making them difficult to discern for visually impaired individuals with limited residual vision. Ramps (sloped pathways) at elevation changes are completely absent along the corridor. Whenever the sidewalk is interrupted at intersections or building entrances, no ramps are provided to allow wheelchair users to safely navigate up or down. Elevation differences range from 5 cm to 15 cm, which are obstacles that wheelchair users cannot navigate independently. Examples of the existing accessibility facilities and their conditions are shown in Figure 6.

(a) No tactile paving

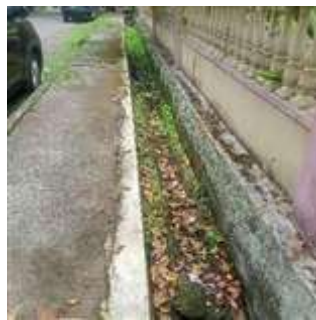
(b) No barrier between the sidewalk and the drainage system

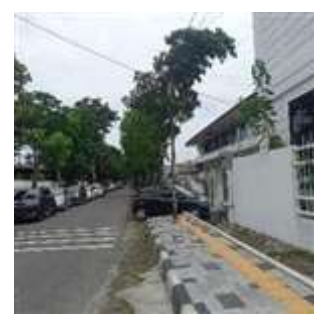
(c) Tactile paving is insufficient

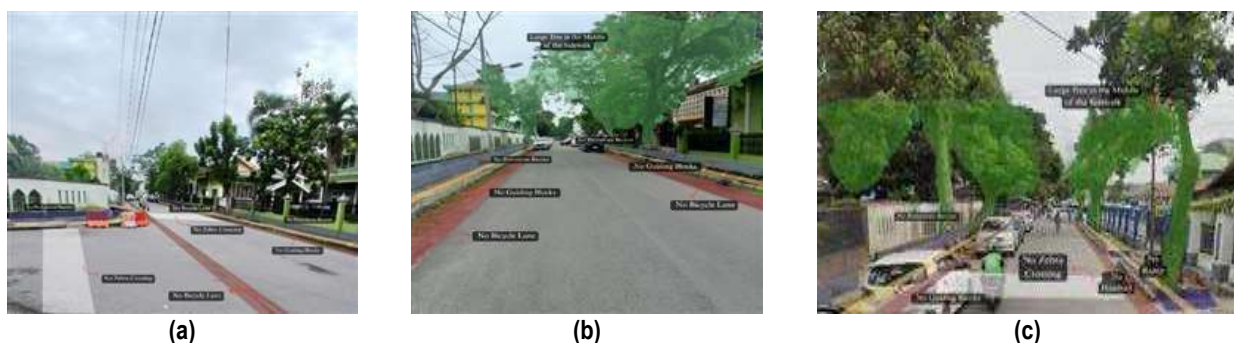
Figure 8. Existing Pedestrian Conditions That Do Not Meet Principles of Universal Design and Disability Accessibility

The principle of equitable use has not been achieved because pedestrian space cannot be utilized equally by all users. Furthermore, the principles of flexibility in use and low physical effort have not been optimally realized due to the presence of physical barriers that impede the mobility of wheelchair users, the elderly, and the visually impaired. Therefore, to make this corridor more aligned with universal design principles, continuous paths, stable surfaces, connected guiding blocks, ramps at every elevation difference, and the reduction of physical barriers that impede pedestrian movement are required. Thus, the Adinegoro–Perintis Kemerdekaan corridor still requires design strengthening to truly support inclusive accessibility for all users. The evaluation of the corridor based on universal design principles is presented in Figure 8.
