Structural Strength of Buildings at the Islamic University of Indonesia Hospital

Indra Tri Saputra*, Noor Cholis Idham, Mahadevi Effia Arkan

Keywords: building structure; earthquake; RESIST software; Universitas Islam Indonesia Hospital (RS UII).

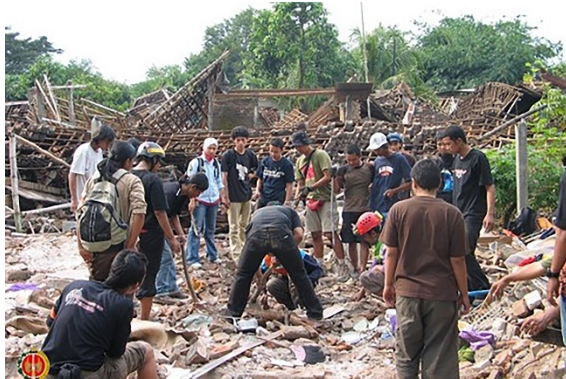
Figure 1. Damage to houses of Bantul residents, Yogyakarta

Yogyakarta is one of the regions in Indonesia that frequently experiences earthquakes. The most devastating earthquake occurred on May 27, 2006, with a magnitude of 6.3, causing significant damage to numerous buildings, including houses, schools, government offices, and other structures (**Figure 1**). The epicenter

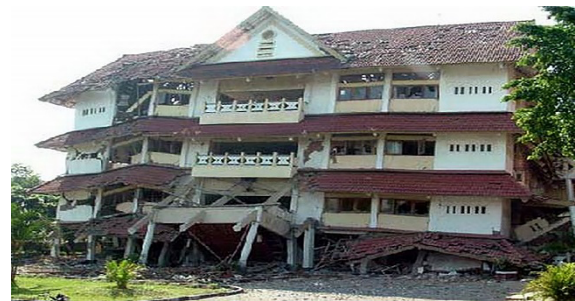
Figure 3. Structural failure of the STIE building due to shaking caused by the earthquake

The earthquake in that year severely damaged building structures in the Bantul area. Data shows that the failure of building structures to withstand vertical and horizontal loads from the earthquake's shocks can lead to their collapse (Figure 3). Putra and Mabui describe an earthquake as the sudden release of seismic wave energy (Putra, Mabui, and Wantoro

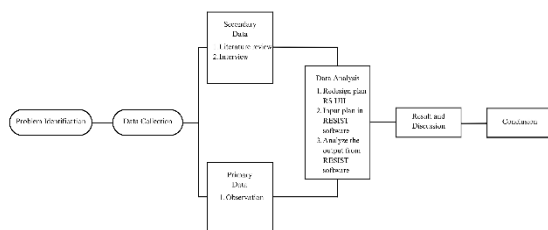
Figure 4. Research Flowchart

In this study, researchers used RESIST software to analyze the building structures at RS UII (**Figure 4**). RESIST is a computer program used by designers to determine the number and size of vertical load-bearing elements in a building. It is used to analyze vertical elements such as columns, beams, walls, and shear walls, assessing their ability to withstand wind and earthquake loads.

The first step taken by the researchers was to model the existing building structure based on primary data in the RESIST software. This involved creating an accurate model of the structural elements by considering the actual conditions and geometry. Once the structural model was created in RESIST, it was analyzed dynamically. The software produced output indicating whether the structure could withstand loads caused by earthquakes and wind forces.

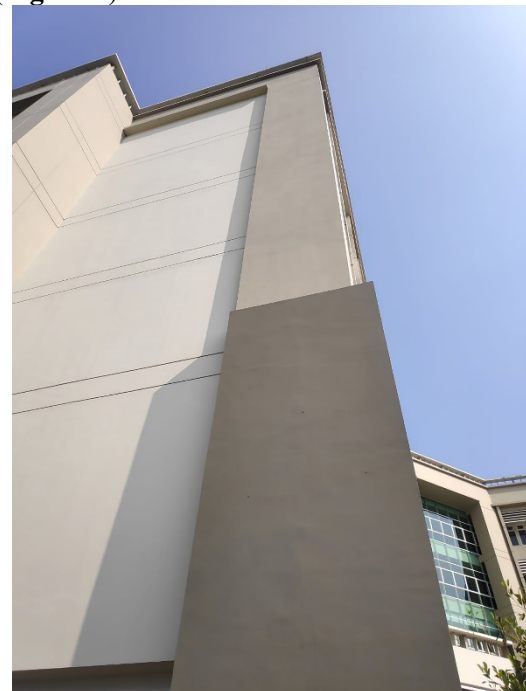
Figure 5. Column at UII Hospital
(Source: Author, 2024)

RS UII, located in Bantul, Yogyakarta, is a hospital that was inaugurated in 2019 to provide health services, supported by expert medical professionals and equipped with sophisticated, modern technology. Researchers found that the structural system used in RS UII is a reinforced concrete structure, featuring columns measuring 50x50 cm with a 6-meter span (**Figure 5**).
