# Analysis of Pedestrian Accessibility for People with Disabilities on Adinegoro–Perintis Kemerdekaan Corridor, Medan City

<sup>1</sup>Architecture Study Program, Faculty of Engineering, Universitas Negeri Medan, Medan, Indonesia

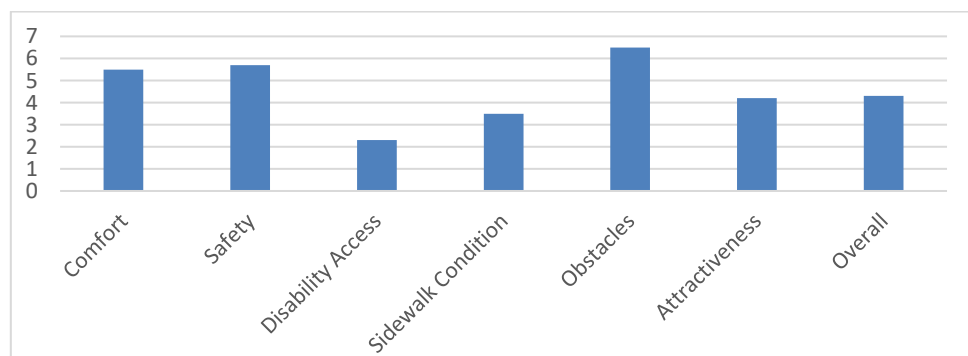
Figure 7. Accessibility Assessment Graph of the Pedestrian Path Based on Research Indicators

The assessment results indicate that pedestrian accessibility in the study corridor remains low and does not meet the needs of all users. The most prominent finding is accessibility for disability communities, which received an average score of 2.3, categorized as very poor. This result indicates that the sidewalks in the corridor are not yet accessible to disability communities, reinforced by observations regarding the absence of guiding blocks, ramps, and other accessibility facilities. This score is also lower than the findings of Hasbana et al. (2024) on Margonda Raya Street, Depok, which received an average score of 4.5 for a similar indicator, thus concluding that conditions in Medan are more severe. The assessment scores for each accessibility indicator are presented in Figure 7.

The physical condition of the sidewalks also received a low rating, with an average score of 3.5, categorized as poor. These findings confirm inadequate lane width, damaged surfaces, and various physical obstacles that impede pedestrian movement. However, this score is still better than accessibility for disability communities, indicating that respondents consider accessibility for disability communities a much more critical issue. Desire to use the sidewalks only reached a score of 4.2, categorized as poor, indicating that people tend to be reluctant to use the pedestrian paths due to their unsuitable condition. This aligns with informants' statements that most pedestrians prefer to walk on the road.
